Clarifying Facts About Timmsdale House, 622 Foss Road Property & the MHAC

Condition Assessment and Recommendations for
Timmsdale, 202 Highway 20 West, Fonthill

Executive Summary

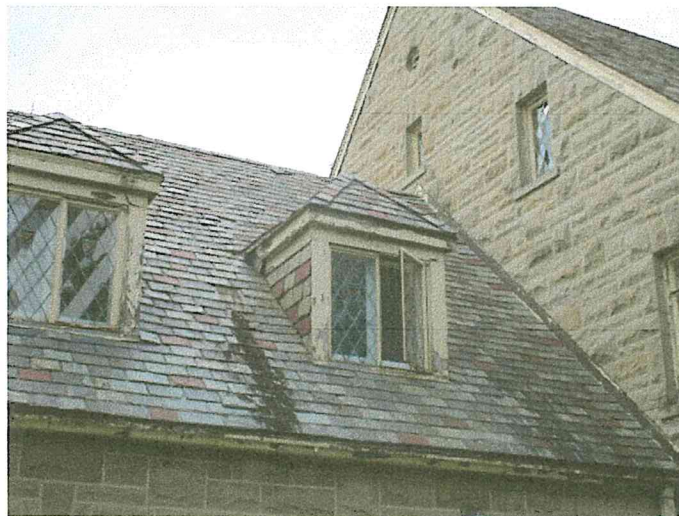
The exterior of Timmsdale has a number of serious building envelope deficiencies that require immediate remediation. The roof has numerous areas of serious, long-term leakage and the slates generally are in poor condition exhibiting breakage and improper repairs. The condition and age of the slates is such that replacement is the only practical option.

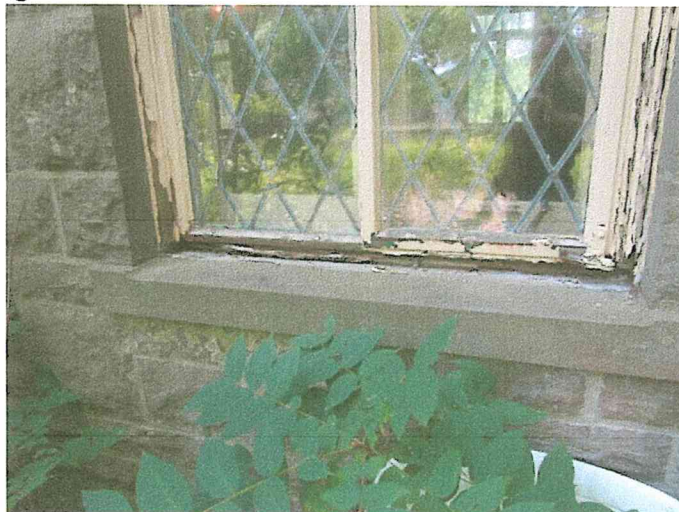
The stone masonry on the exterior of Timmsdale is in good condition for the most part. There are some areas of concern arising from missing eavestroughs or conductors however at present these can be corrected with repointing once the roofing and drainage issues have been solved. Overall the Queenston limestone is in excellent condition and the mortar joints and pointing are acceptable for the majority of the walls. The wood fascia and mouldings are in poor to very poor condition. Paint is deteriorated or completely absent from many surfaces. The exterior trims require extensive repairs and proper preparation and painting. The trims on the dormers on the garage wing are in particularly poor condition and are in need of immediate repairs. The windows throughout the building are in need of maintenance, repairs, and painting. The steel window frames and sash are in reasonably good condition in that they are solid and intact, however they have rusted to the point that removal of the glazing, stripping of all the paint, and proper preparation and painting with an epoxy system are required before the glazing is reinstated. The leaded diamond lights are in reasonably good condition, however there are some broken panes and there are a number of deflected or bulging lights. They need to be repaired and all of the lead comes examined for deterioration or loss of seal to the glass. The glass must be reset in putty as necessary. Many of the wood window jambs and sills have rotted to the point that they require replacement. In localized areas, epoxy repairs may be carried out but replacement is the only solution for many of the openings.

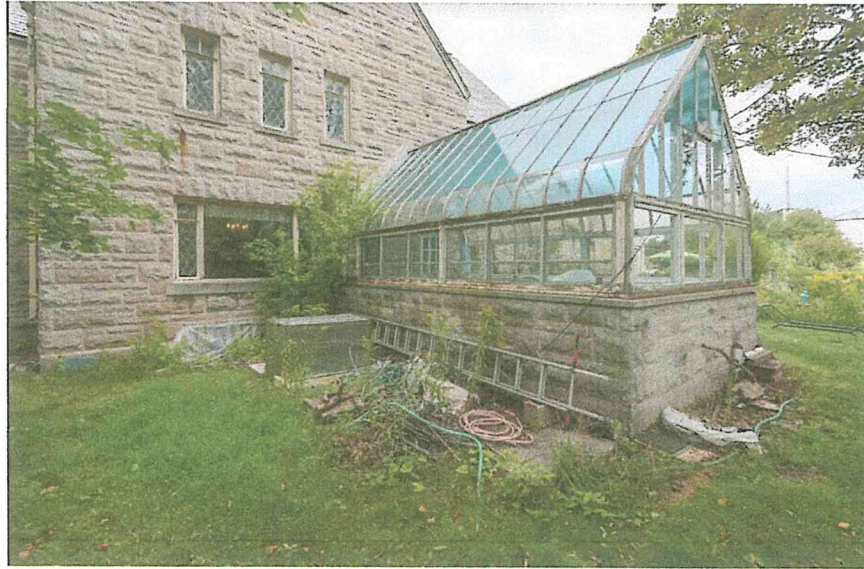
The conservatory on the south side of the building is a single-glazed building with a combination of steel and wood window frames, aluminum roof battens, and a cast iron gutter system. The windows in the side walls open with a traditional green-house style hardware system that operates all sash simultaneously. The roof glass is a light blue tinted cathedral glass to reduce the summer time heat gain. The complete glazed enclosure sits on a masonry kneewall with the same Queenston limestone exterior finish as the rest of the house. The only access to the conservatory is through a connecting door into the house, there is no exterior entrance. The paint finish on the conservatory

framing ranges from poor to non-existent. The complete conservatory glazing system requires dismantling, rehabilitation, and reglazing. There is a concrete cistern below the floor of the conservatory, the condition of which was not observed.

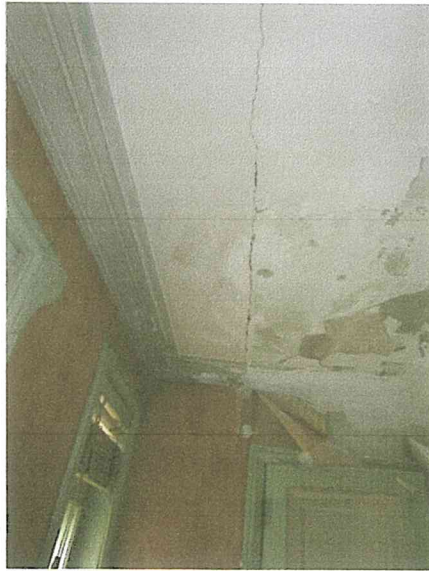
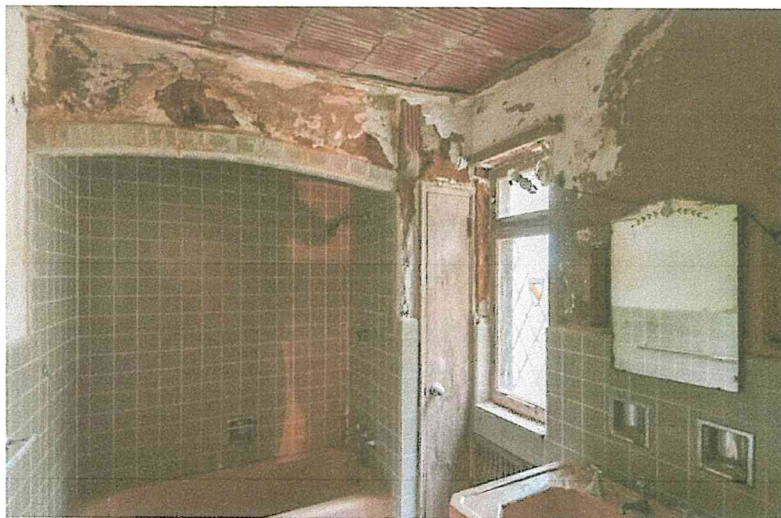
The first impression is soon replaced by concern for the poor condition of much of the space and the obvious urgency for repairs. The roof and wall leaks have resulted in major deterioration of plaster surfaces and mouldings in particular. The masonry construction of the building is the only thing that has saved some areas from serious structural decay and/or failure. There is only one serious issue of deterioration leading to a structural failure evident to a visual inspection: there is a long, straight crack in the east-west direction in the ceiling and wall of a second floor bedroom, just inside a south-facing gable. It apparently follows the line of a joist within the structural tile and reinforced concrete floor system, and likely indicates the result of a chronic water leakage problem and possibly the effect of frost on the saturated masonry. A rigid structural system such

as this house has is prone to propagation and telegraphing of cracks through longer distances than a more flexible system such as wood or steel framing would exhibit. One other structural concern is an opening in a masonry wall that was created by the present owners. The opening was cut through structural clay tile however no lintel or supporting frame was introduced. The location is in a relatively vulnerable position, and could possibly lead to further cracking of the wall.

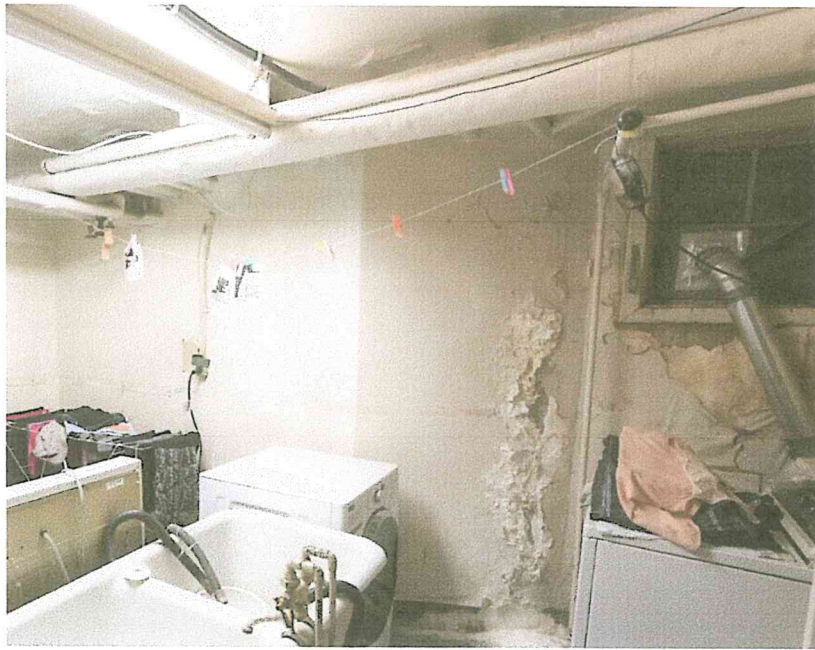
The basement level of the house exhibits the result of many years of leakage and poor drainage and ventilation. Deterioration of finishes throughout is a serious concern, however the basement level must have a hazardous substances survey before any work can be carried out. The presence of mould is a certainty, and there is a high likelihood that asbestos and lead-based paints are present. While it cannot be determined without laboratory testing, much of the insulation on the heating system boilers and pipes appears to contain asbestos. The plaster could also contain asbestos, and it is very likely that the paint, much of which is peeling and falling off, contains lead. There is a vault in the rear of the house which has contained oil tanks, testing for any leakage is mandatory. There are a number of older refrigeration systems on some walk-in coolers in the
