Pelham Water Distribution System
ANNUAL SUMMARY REPORT

January 1, 2017 to December 31, 2017

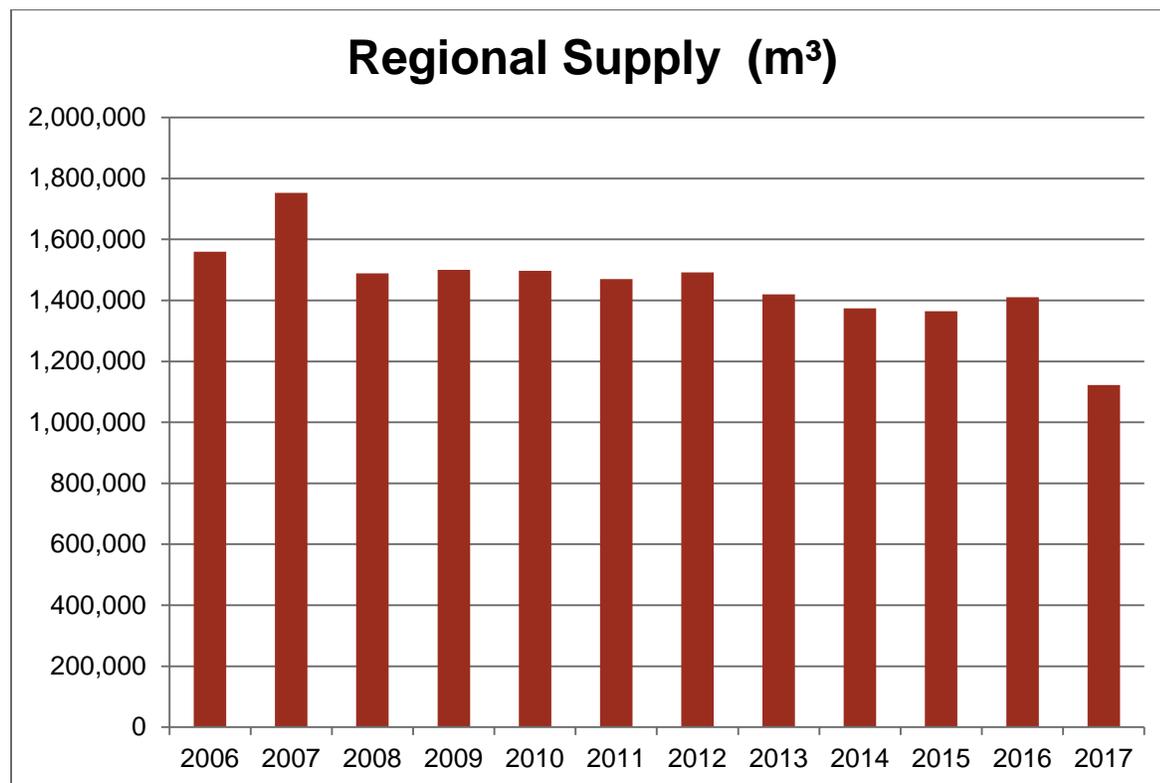
Figure 1 –2017 Total Water Supplied by the Region of Niagara

The totals in this table are also reflected in the graph below, **Figure 1**.

It is anticipated that the decreasing general demand may be generally attributed to decreasing customer demand, and social conservation initiatives.

Year	Supply (m ³)
2006	1,559,490
2007	1,752,470
2008	1,488,891
2009	1,499,700
2010	1,497,110
2011	1,469,470
2012	1,491,850
2013	1,420,220
2014	1,374,130
2015	1,364,450
2016	1,410,410
2017	1,122,740

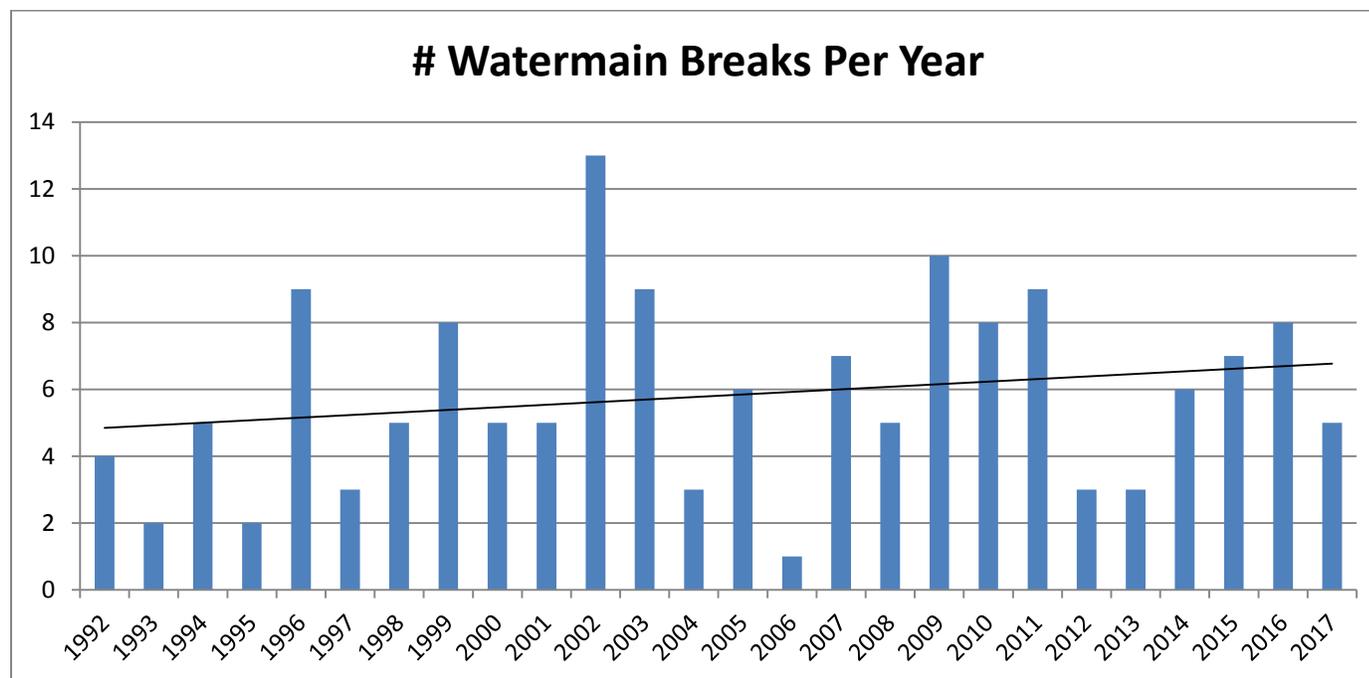
Figure 2 – Town of Pelham - Water Main Breaks

A total of five main breaks occurred in 2017, summarized in **Table 4**. **Figure 2** shows the overall trend for the total number of water main breaks.

The trend line suggests the general number of breaks is increasing. The following should be noted:

1. The likelihood of breaks increases where the water main pipe material is cast iron - Approximately 17% of the distribution system is made up of cast iron pipe with an average age of 60 years.
2. The likelihood of breaks increases where the diameter of the cast iron pipe is 150mm - most of the cast in the system is of this size.
3. The likelihood of breaks increases where the normal operating pressure of the watermain is 65psi or greater - the average system pressure is 71.6psi. The lowest recorded pressure in the system is 42psi and the highest is 95psi.
4. There is one active lawsuit related to watermain break property damage. Risk of property damage increases where breaks occur in urban areas without stormwater infrastructure.

Date	Location	Type of Pipe	Suspected Cause	Replacement in 20-year Capital Plan
2/4/17	EMMETT STREET	CAST IRON	AGE & CONDITION	2024
2/18/17	BACON LANE	ASBESTOS CEMENT	SETTLEMENT DUE TO NEW SERVICE INSTALLATION	- -
7/6/17	CLARE AVENUE	CAST IRON	AGE, CONDITION, PRESSURE	2019
12/17/17	STATION STREET	CAST IRON	AGE & CONDITION	2018
12/22/17	LORIMER STREET	CAST IRON	AGE & CONDITION	2022
