# Town of Pelham Sanitary Sewage Collection System

## 2024 Annual Performance Report

January 1 to December 31, 2024

CLI ECA No. 072-W601

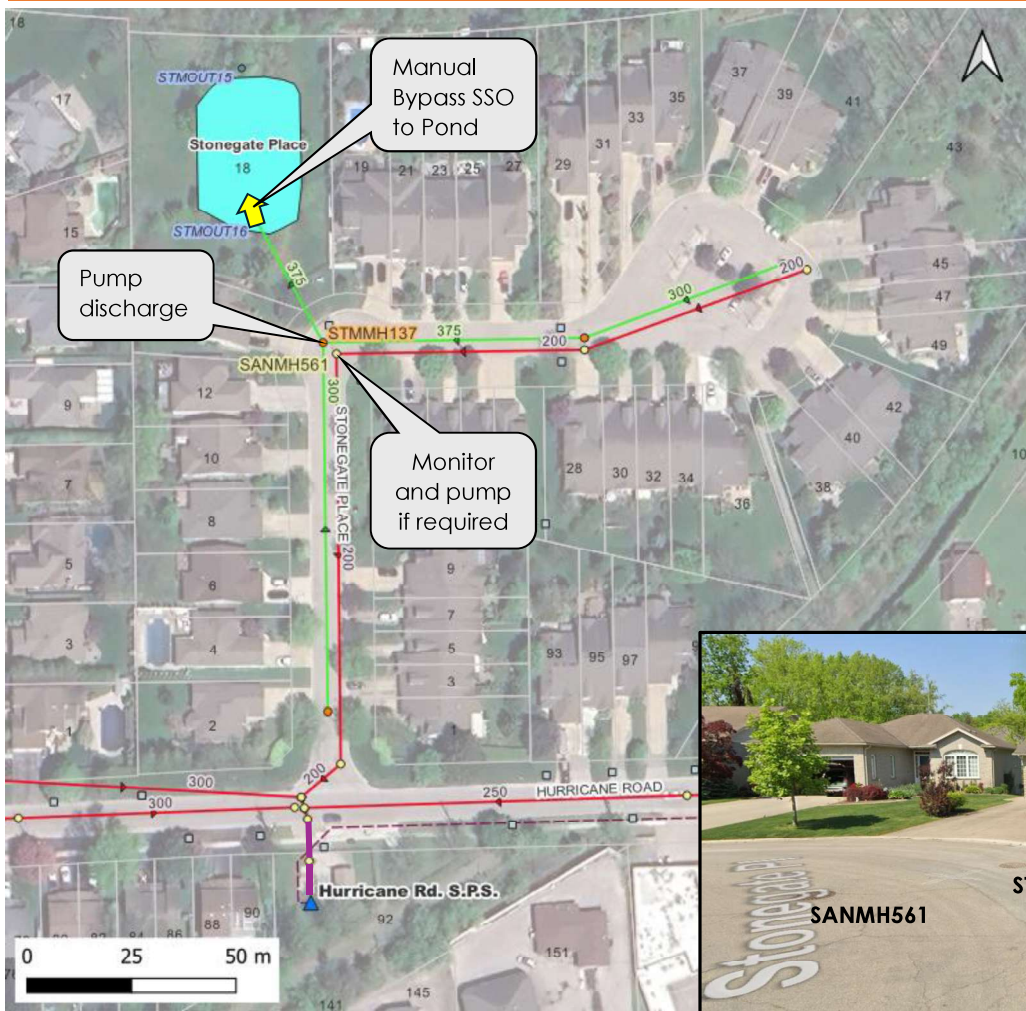
## Sanitary Sewer Bypass – Stonegate Place

PW-SAN-VIS-002

See Appendix 2 for details on the Town's Stonegate Place Bypass Procedure.
