Clarifying Facts About Timmsdale House, 622 Foss Road Property & the MHAC

Condition Assessment and Recommendations for
Timmsdale, 202 Highway 20 West, Fonthill

Executive Summary

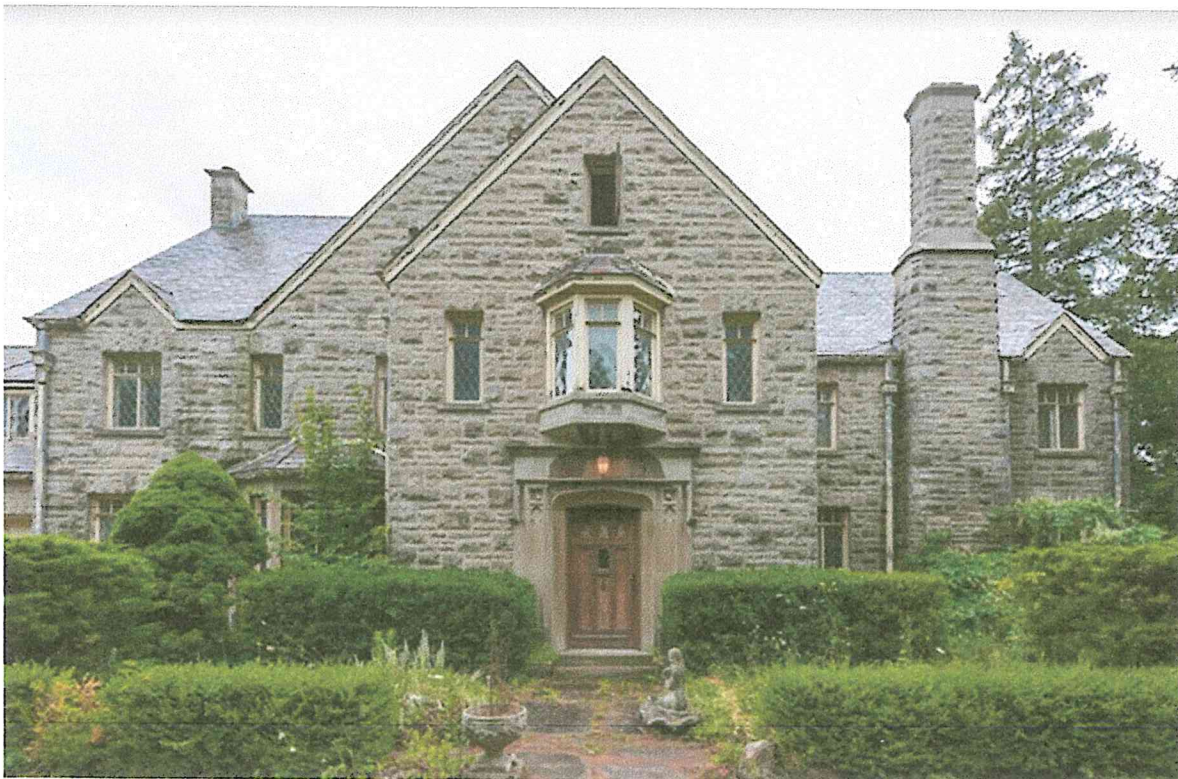
Timmsdale, 2016

The existing single family dwelling at 202 Highway 20 West in Fontheil is visibly deteriorated both inside and out, and has serious building envelope issues that are directly related to and/or causing many of the immediately apparent major problems. It is in need of substantial repairs, in large part because it has had minimal maintenance and essentially no professional repairs for some three decades. The structure is basically sound, with only minor areas of concern. The roof and rainwater management system have reached or exceeded their practical service life and are in need of immediate replacement. The windows require immediate and extensive repair and restoration. The exterior stone veneer is in relatively good condition but requires some maintenance to prevent future problems.
